# New York State Department of Transportation

## Yellow Flag NB2222W003

**BIN: 1065318**  
**Feature Carried:** 278I278IX2M23027  
**Feature Crossed:** 6TH AVENUE  
**Orientation:** 8 - NORTHWEST  
**Region:** 11 - NEW YORK CITY  
**County:** KINGS  
**Political Unit:** City of NEW YORK  
**Approximate Year Built:** 1962  
**Posted Load Matches Inventory :** Yes  
**Bridge Load Posting (Tons) :** Not Posted for Load  
**Primary Owner:** New York State Department of Transportation  
**Primary Maintenance Responsibility:** 12 - State - Subcontracted to another Party  
**Typical or Main Span Type:** 3 - Steel, 02 - Stringer/Multi-Beam or Girder  
This Bridge is not a Ramp  
**Number of Spans:** 322

Location: Span 222 Girder G19 at Pier 221

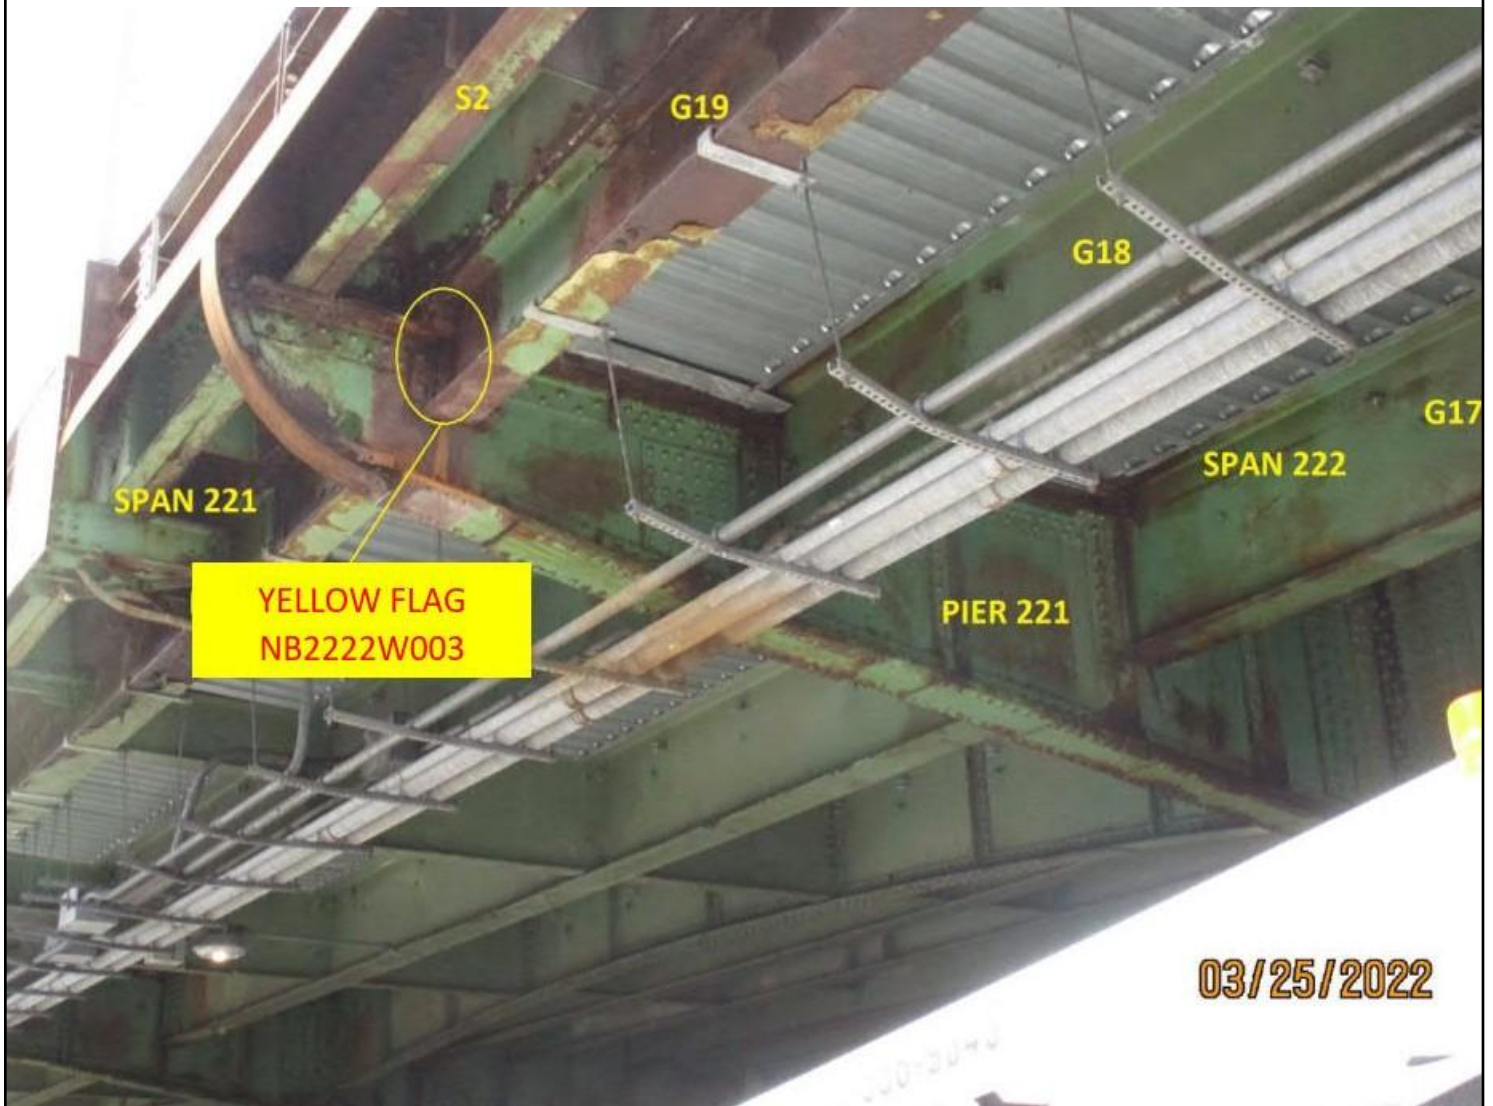
Photo Number: 1

Description: The right connection angle at Girder G19 to the pier cap at Pier 221 exhibits 100% section loss at the fillet for the full height of the connection angle (no change from the previous inspection).

**Attachment Description:** Span 222, Girder G19 at Pier 221 – General view of flagged location. Looking begin left.

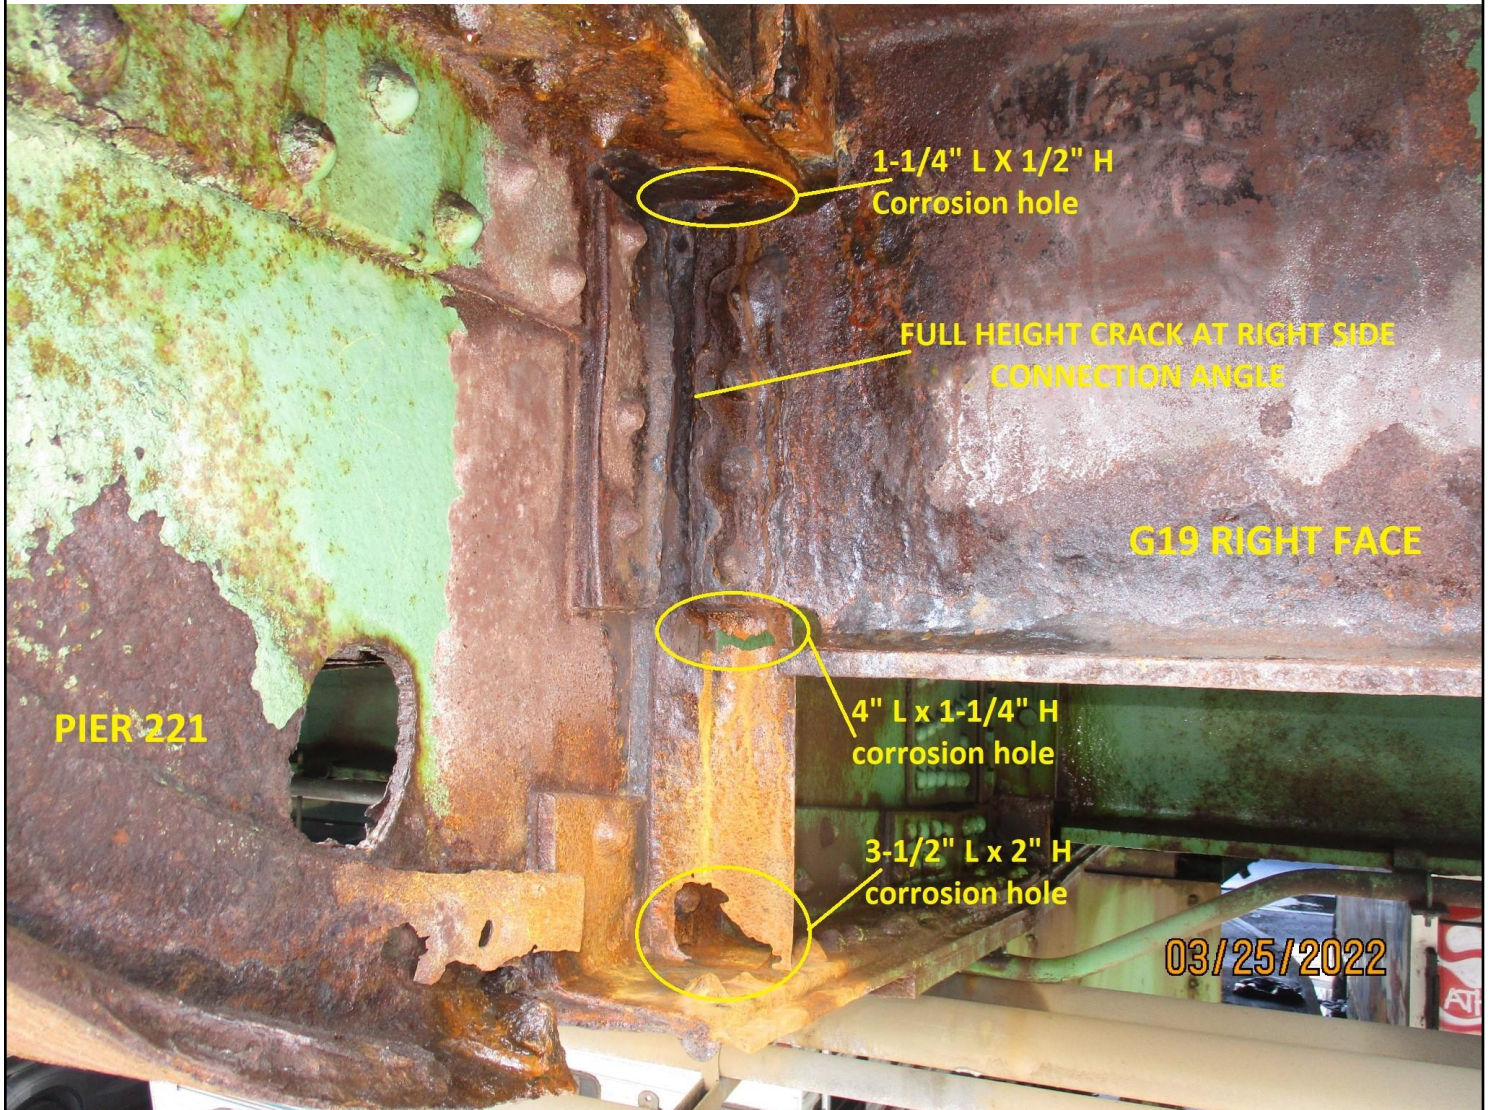
Photo Number: 2

The left connection angle exhibits a corrosion hole directly below the girder web measuring 4" L x 1.25" H (no change from the previous inspection). A corrosion hole located at the base of the angle measures 3.5" L x 2" H (no change from previous inspection) and another hole at the top of the angle measuring 1-1/4" L x 1/2" H (not previously noted).

**Attachment Description:** Span 222 at Pier 221. Girder G19 right face. Full height crack in the right connection angle at the fillet and corrosion holes in the left connection angle. Looking left.

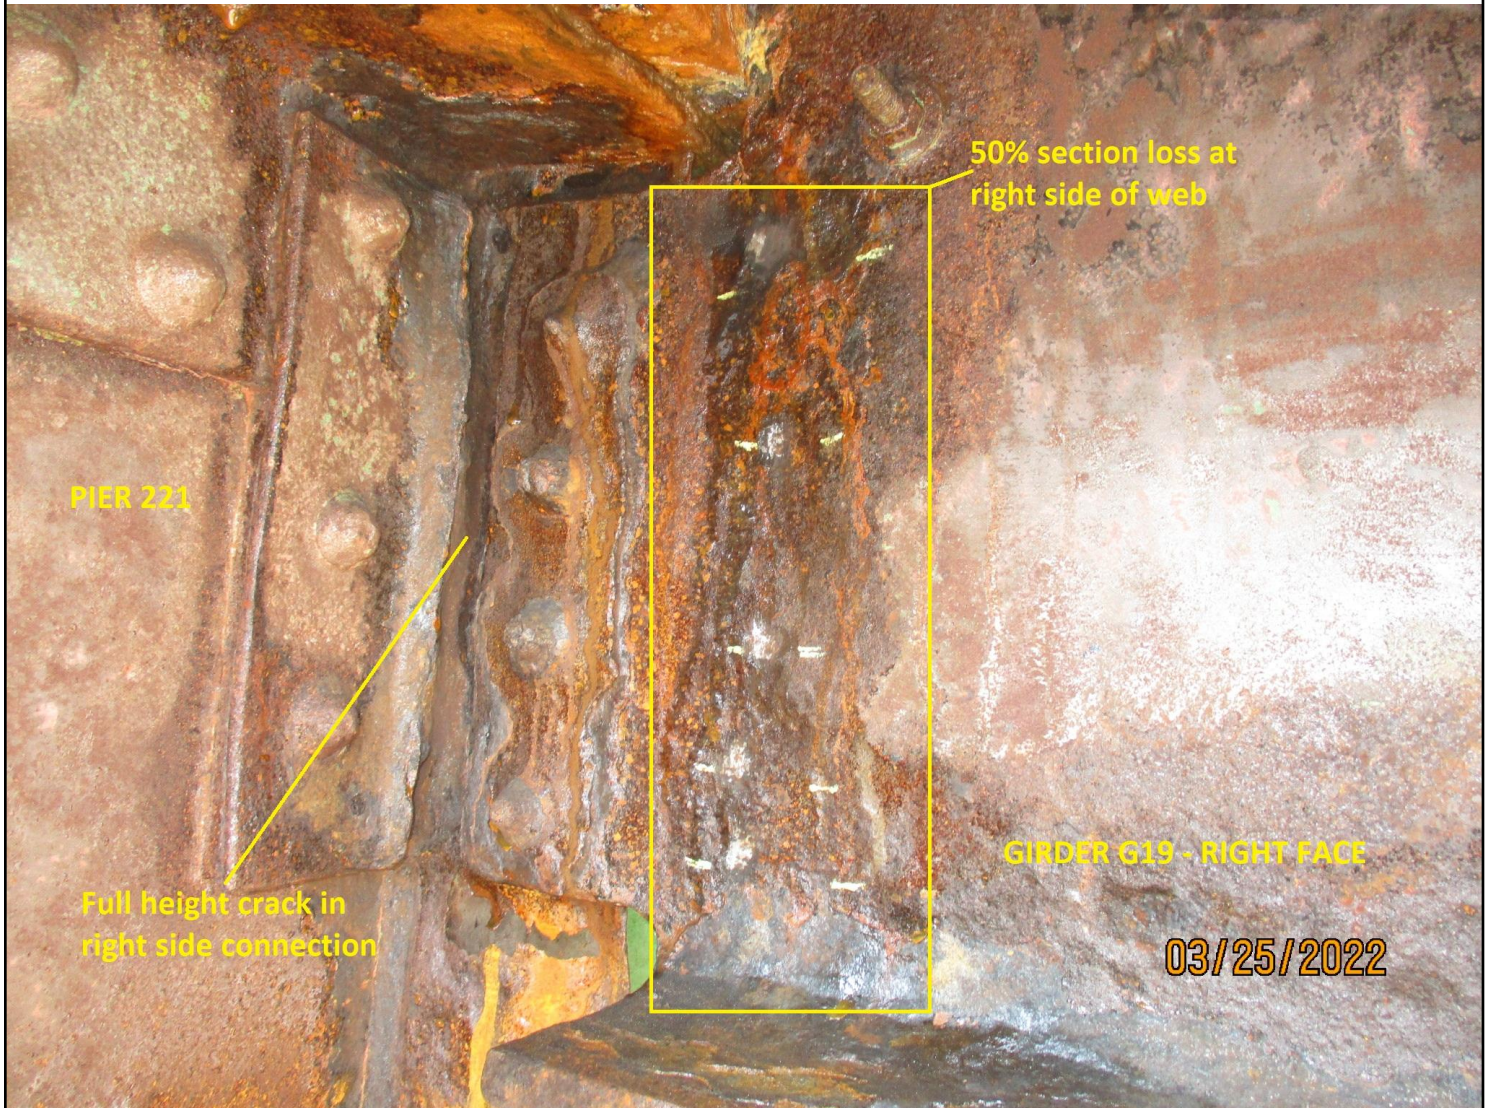
Photo Number: 3

Additionally, the web at Girder G19, along the connection angle, exhibits 50% overall section loss for the full height (no change from the previous inspection).

**Attachment Description:** Span 221 at Pier 220. Girder G19 right face. Close-up view of flagged location. Heavy section loss to the web of the Girder and 100% section loss of the connection angle fillet. Looking left.

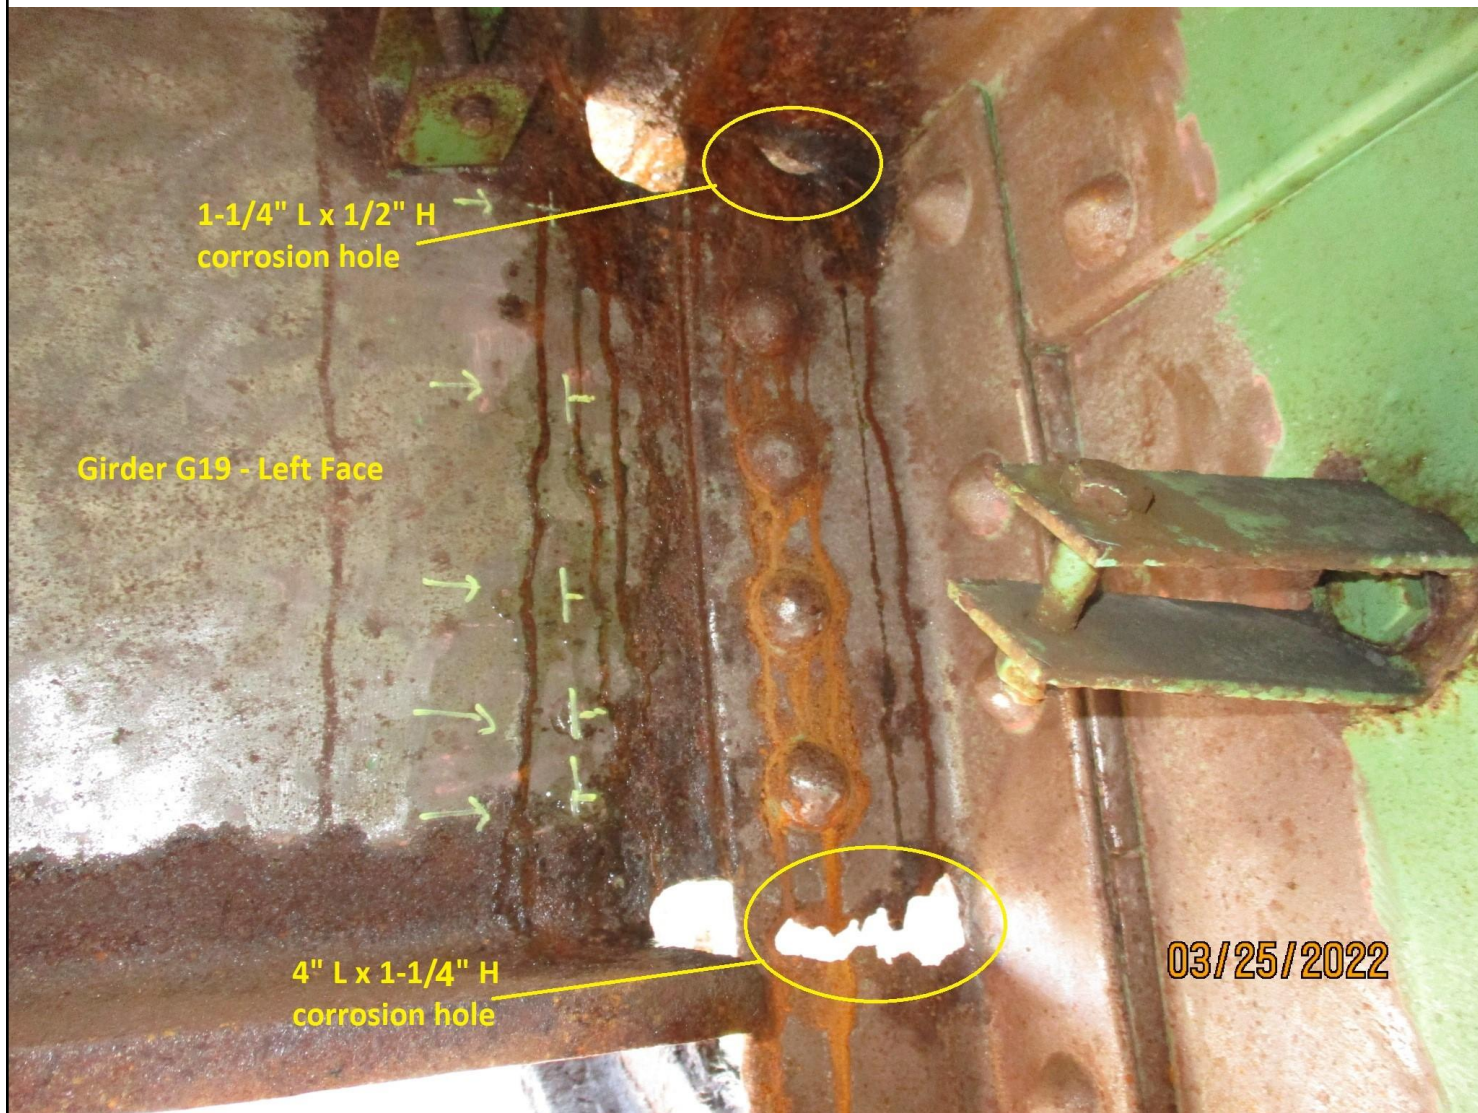
Photo Number: 4

**Attachment Description:** Span 221 at Pier 220. Girder G19 left face. Corrosion hole in the left connection angle. Looking right.

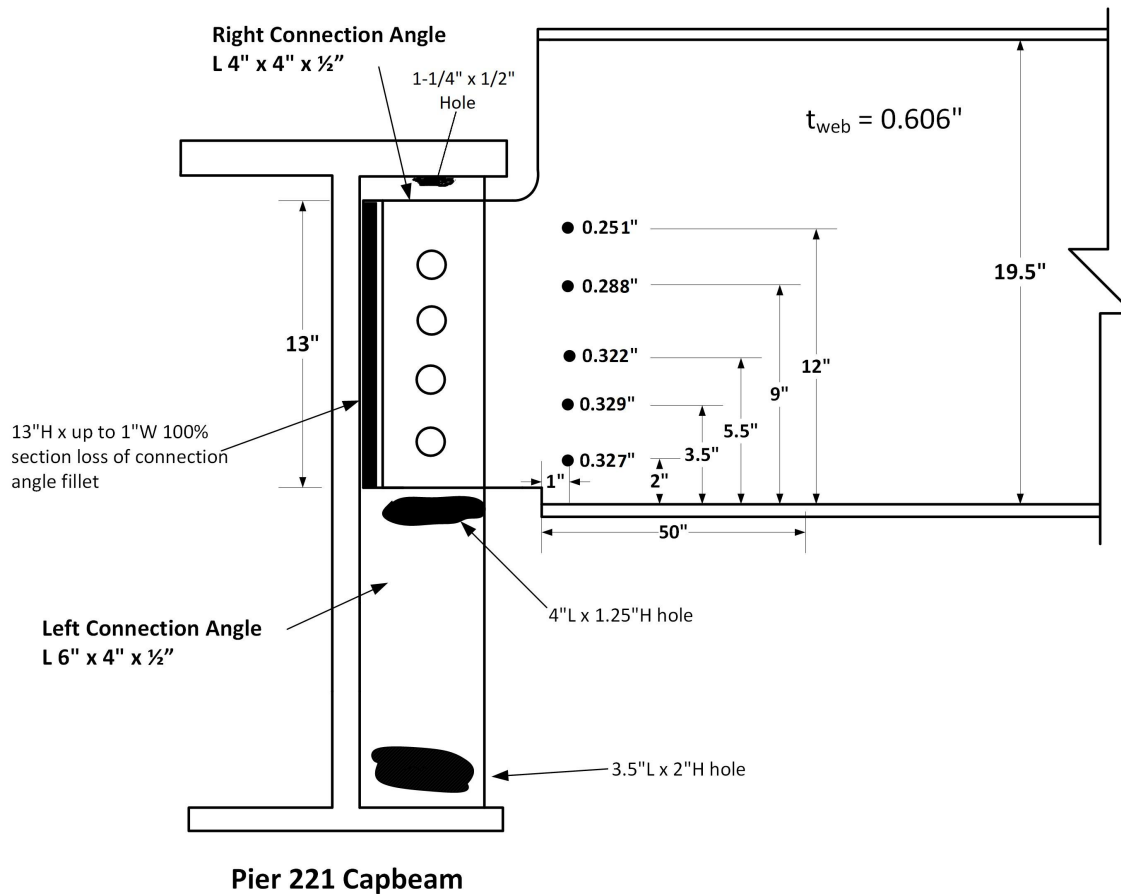
Photo Number: 5

Average remaining web section –  $(0.327 + 0.329 + 0.322 + 0.288 + 0.251)/5 = 0.303"$ Web section loss –  $(1 - (0.303/0.606)) \times 100\% = 50\%$ **Span 222, Girder G19 Right Face at Pier 221**  
**(Looking left)**

**Attachment Description: Span 222 G19 at Pier 221 Sketch**

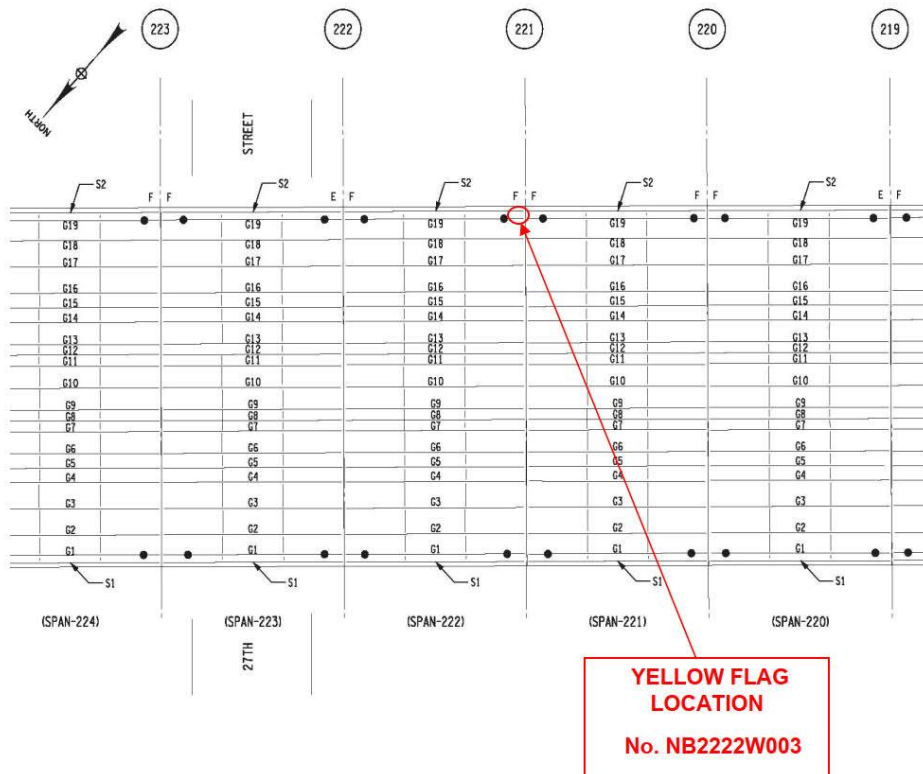
Photo Number: 6

1.The affected member, Girder G19 is a load path redundant steel girder consisting of a web depth of 19.5" inches and thickness of 0.606 inches and is located under the deck in the roadway, approximately 12" off the edge of curb line/safety walk. All dimensions were measured in the field.

2.The adjacent Girder G18, is 5'-5" on center, exhibits approximately 20% localized section loss to the lower web above bottom flange and along connection angle.

3.The adjacent Stringer S2, approximately 24" on center, acts as a support for the railing and curb area above and is in good condition.

**Attachment Description: Span 222 G19 at Pier 221 Framing Plan**
